# Solid Waste Management Case Study

## Remediation of Burning Dumpsite Mansoura, Governorate of Dakahleya

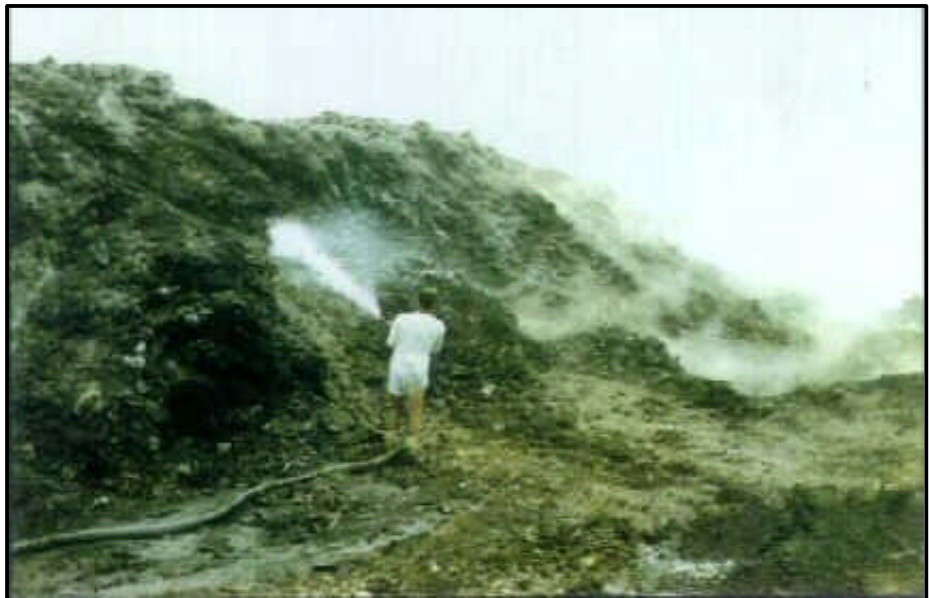
*Dousing Smouldering Hot-Spots in Areas of Burnt Waste*

However there was a huge volume of burnt waste that continued to smoulder in places. These areas were doused in water by pumping treated effluent from the discharge canals of the adjoining sewage treatment works. Despite this there were still hot spots which continued to smoulder at depth. These were excavated with a back-end loader and doused.

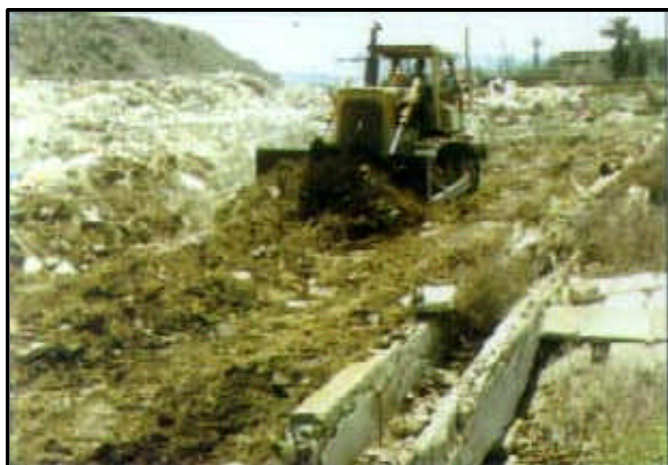
*Preparing New Waste Cells and Removing Cover Materials*

The bulldozer was then used to tip, level and compact the waste in layers, or cells, between 10-20m wide and to a height of 2m. The waste cells were covered at the end of each day with a thin layer (150mm) of soil excavated at the site or by using suitable incoming construction waste. Daily cover minimises the risk of spontaneous combustion and reduces odour, flies and the amount of wind blown litter.

Cells were planned over the available areas and were prepared several days ahead by recovering and storing available cover material. Banks, 2m high, were also prepared around the proposed cell. Tipping in successive layers on the top of existing cells was practised up to a maximum height of 10m.

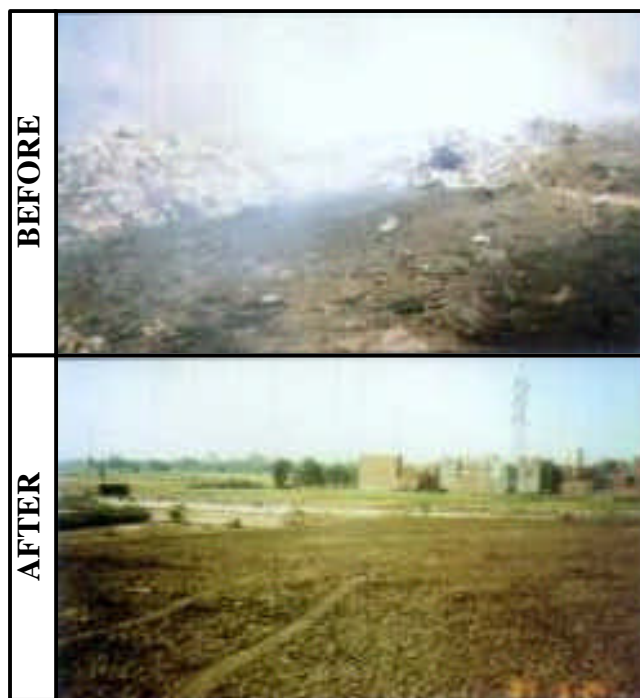
*Before and After Remediation : Residents Previously Suffered Smoke ,Odour and Litter Nuisance*

The burnt out waste remained in unstable mounds up to 12m in height. These areas were then graded to form a gentle slope and covered with soil excavated at the site. The covering served to:

With grading and top dressing the area had been beneficially upgraded and was left in a suitable condition to be transformed into a public garden as planned by the Governorate.

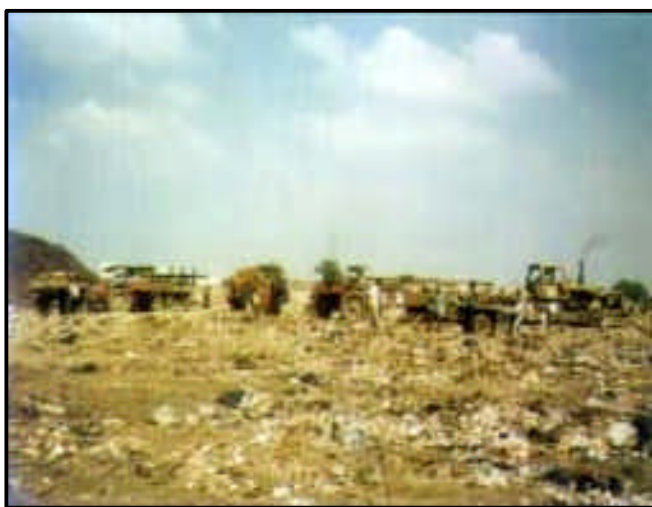
*Tipping Operations at Mansoura Dumpsite*

Incoming waste was dumped and spread out by a shovel loader to allow scavengers access to recover any recyclable materials. By controlling the area where scavengers could work this reduced the safety risk as previously they roamed the site often getting in the way of incoming vehicles.
